Engine: All Technical Service BulletinsTechnical Service Bulletin # **04-06-01-029E**Date: **100429****Vehicle - Engine Crankcase and Subsystems Flushing Info.
INFORMATION****Bulletin No.:** 04-06-01-029E**Date:** April 29, 2010**Subject:** Unnecessary Flushing Services, Additive Recommendations and Proper Utilization of GM Simplified Maintenance Schedule to Enhance Customer Service Experience**Models:**

2011 and Prior GM Passenger Cars and Trucks (including Saturn)

2010 and Prior HUMMER H2, H3

2005-2009 Saab 9-7X

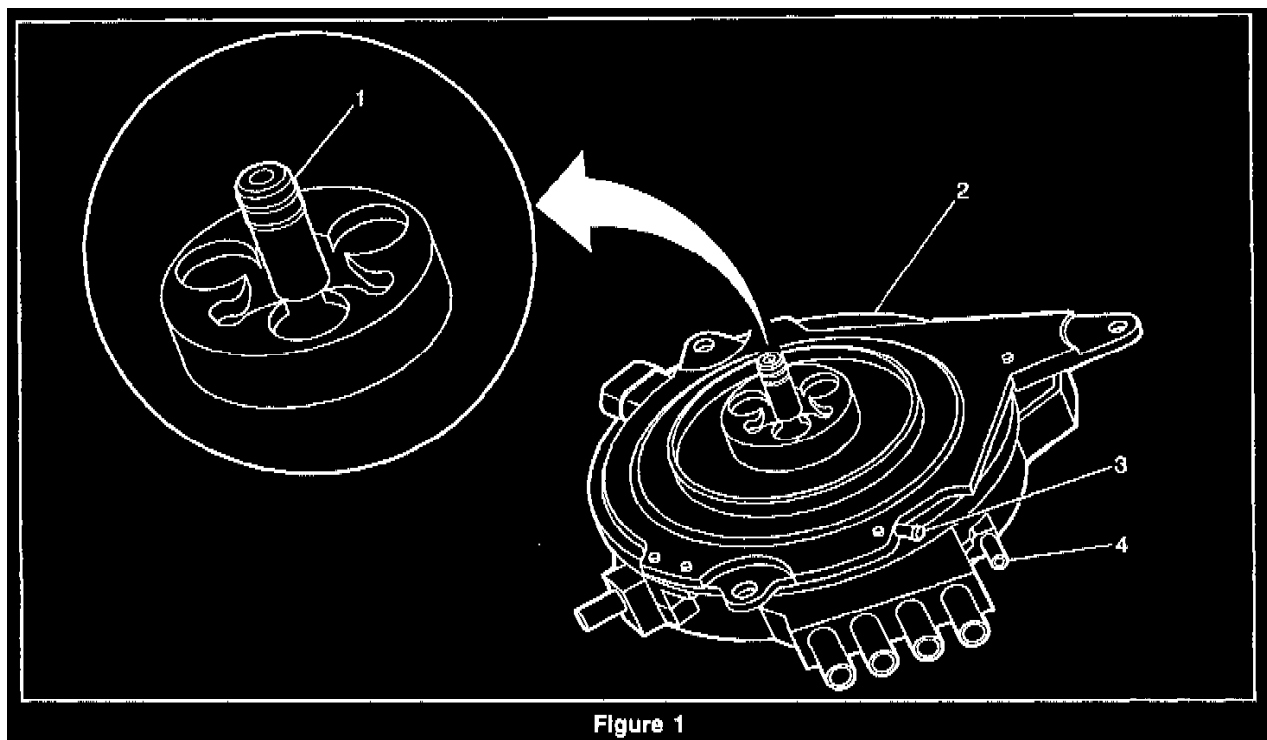
Figure 1

The (ABITS) cap and rotor may exhibit carbon tracking, cracking, or water intrusion which can cause an engine miss and/or poor driveability symptoms.

1. Opti-Spark Distributor II (Pin Drive - WITH positive vent system) can be identified by the intake manifold vacuum hose connection (3), air intake duct hose connection (4), or non-splined pin drive (1). Refer to Figure 1.

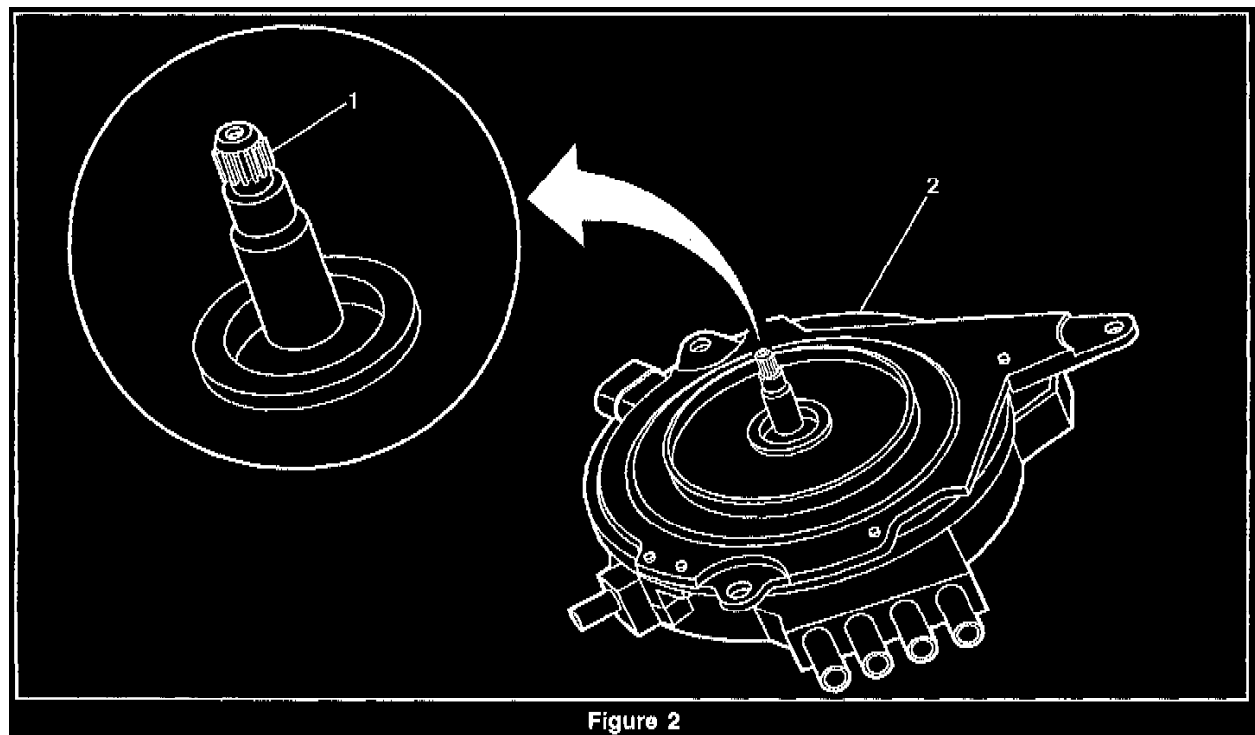
Figure 2

2. Opti-Spark Distributor I (Splined Drive - WITHOUT positive vent system) can be identified by the splined pin drive (1), or the lack of intake manifold vacuum hose connection and air intake duct hose connection. Refer to Figure 2.

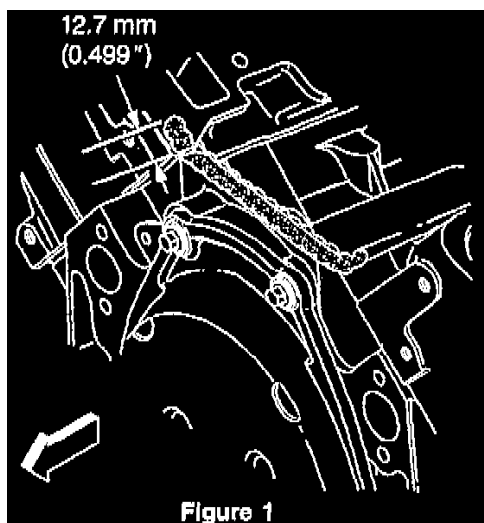
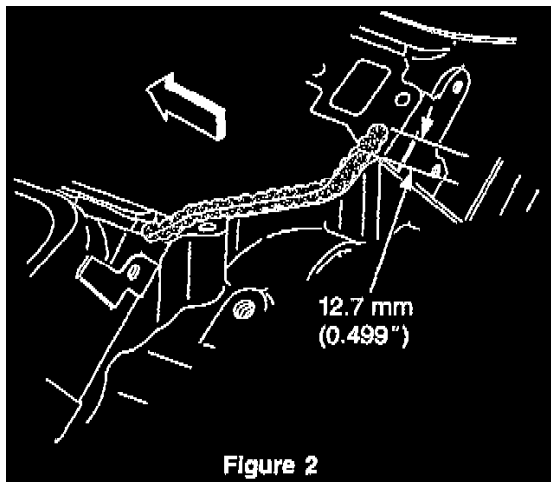
Figure 2

Oil leaks at mating surfaces between the intake manifold and engine block. Sometimes called "China Wall." (See Figures 1 and 2).

It is very important to identify the source of the leak. Clean and dry area thoroughly before inspection. Use black light and oil dye to identify the source. If the China Wall area is found to be the source of the leak, reseal the mating surfaces with "3 BOND" RTV (P/N 12346141).
