Engine: All Technical Service Bulletins

Technical Service Bulletin # **04-06-01-029E**

Vehicle - Engine Crankcase and Subsystems Flushing Info. INFORMATION

Subject: Unnecessary Flushing Services, Additive Recommendations and Proper Utilization of GM Simplified Maintenance Schedule to Enhance Customer Service Experience

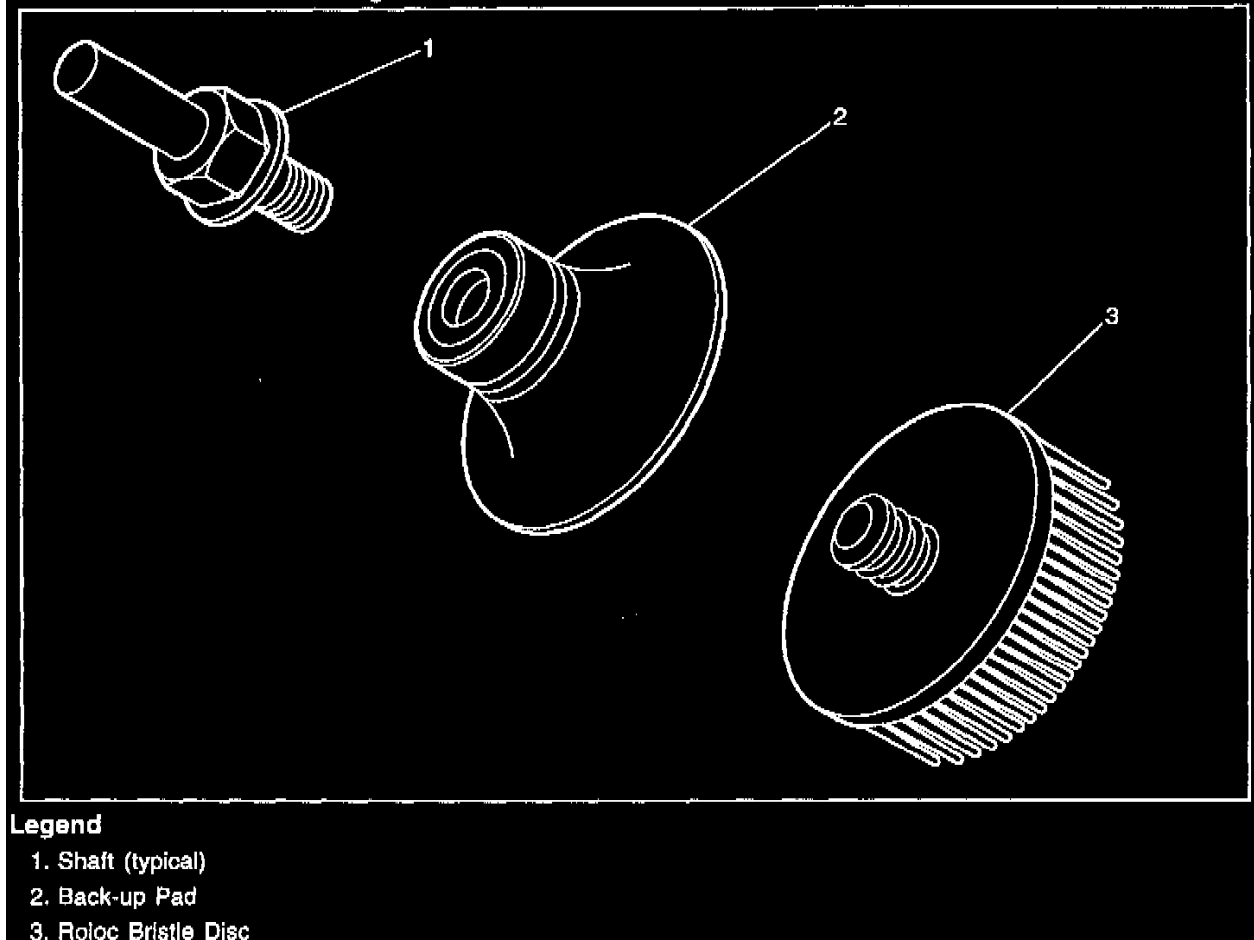
Figure 1 - 3M® Roloc Bristle Disc Identification

Non-3M(R) Back-up pad's may have a deeper threaded cavity which causes the button (on the Disc) to continue to tighten down during use. This can cause the button to separate from the disc resulting in disc fly off and potential operator harm.

The Discs (see Figure 1 - 3M(R) Roloc Disc Identification) are available in different grit levels, with suggested applications as shown:

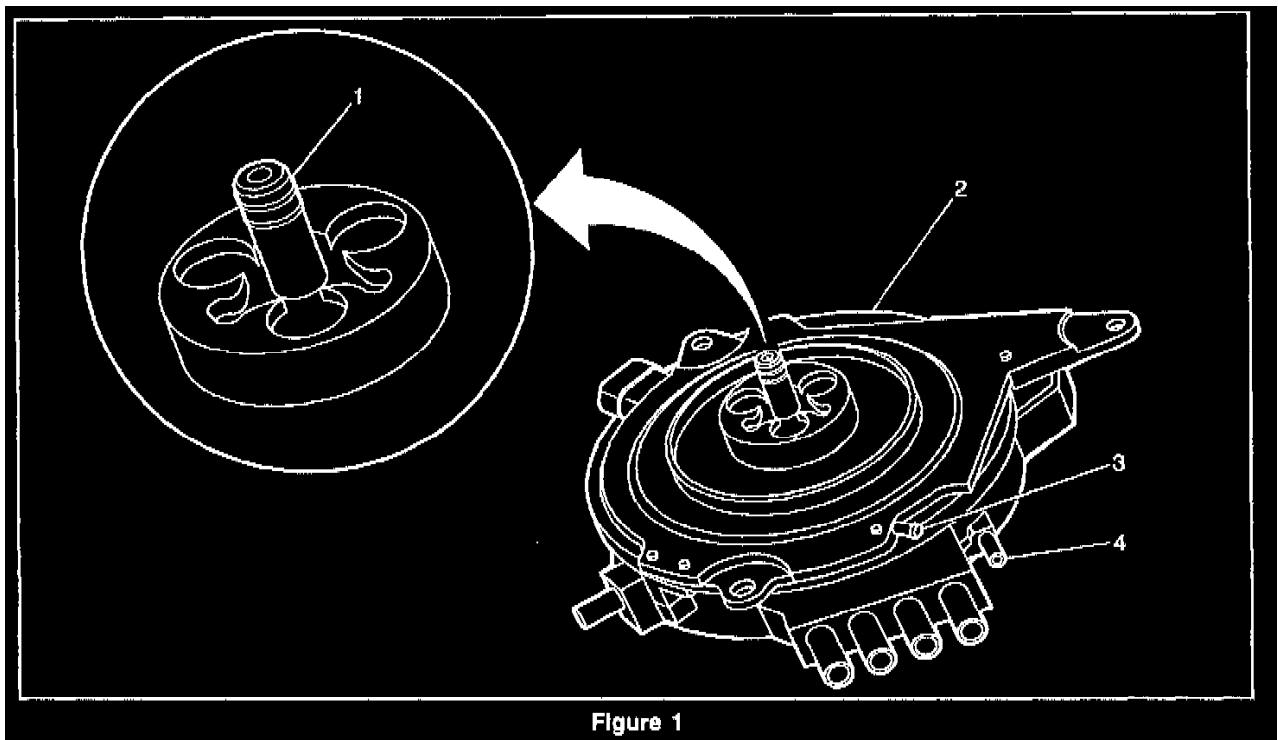
Figure 1

1. Opti-Spark Distributor II (Pin Drive - WITH positive vent system) can be identified by the intake manifold vacuum hose connection (3), air intake duct hose connection (4), or non-splined pin drive (1). Refer to Figure 1.

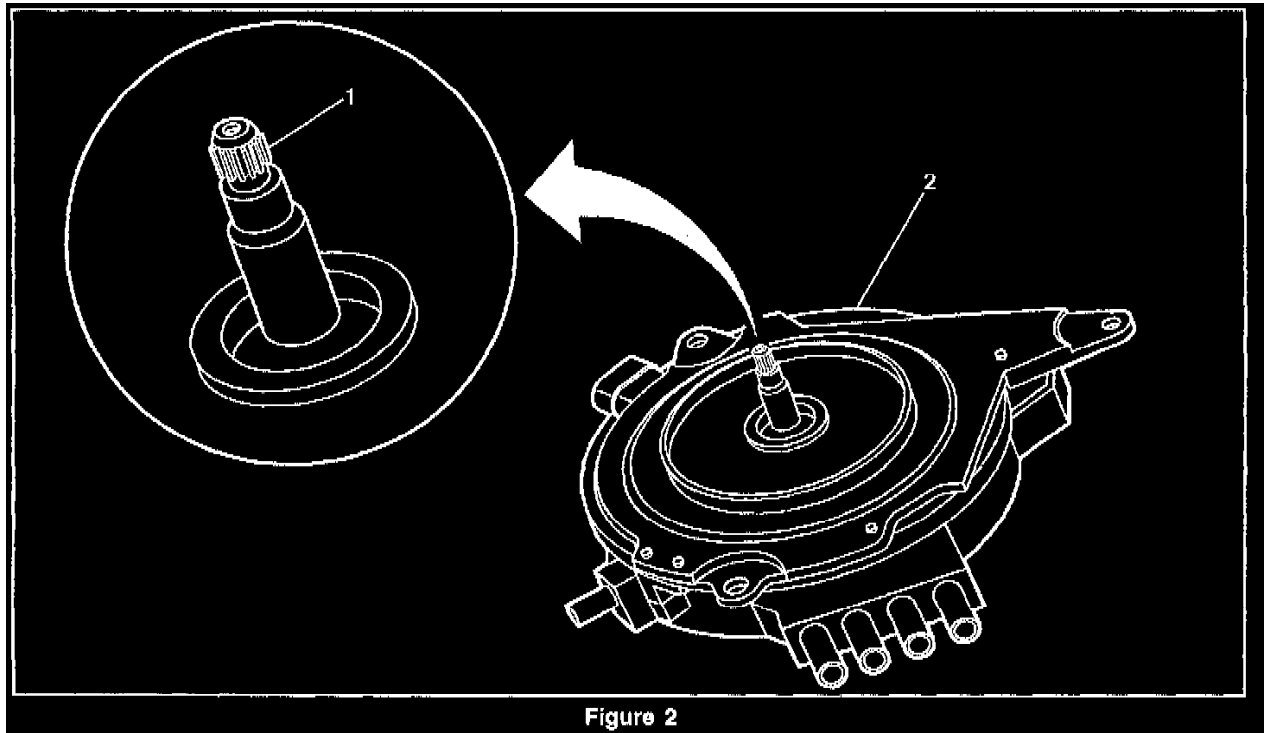
Figure 2

2. Opti-Spark Distributor I (Splined Drive - WITHOUT positive vent system) can be identified by the splined pin drive (1), or the lack of intake manifold vacuum hose connection and air intake duct hose connection. Refer to Figure 2.

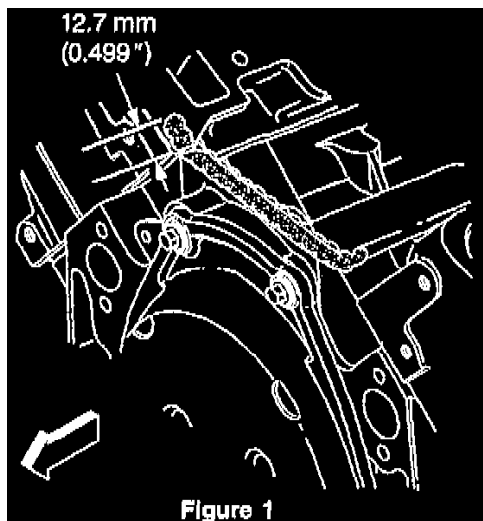
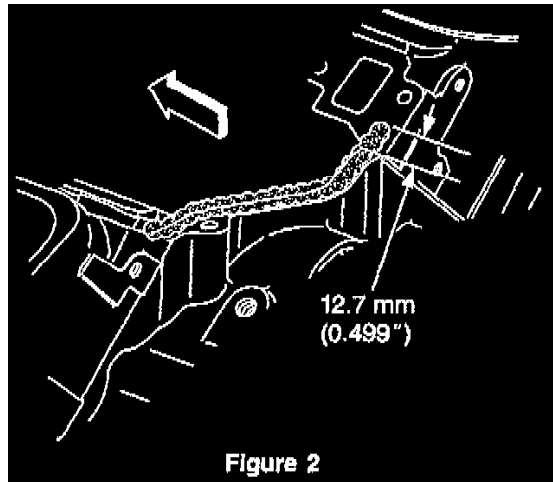
Oil leaks at mating surfaces between the intake manifold and engine block. Sometimes called "China Wall." (See Figures 1 and 2).

It is very important to identify the source of the leak. Clean and dry area thoroughly before inspection. Use black light and oil dye to identify the source. If the China Wall area is found to be the source of the leak, reseal the mating surfaces with "3 BOND" RTV (P/N 12346141).
