Engine: All Technical Service Bulletins

Technical Service Bulletin # **04-06-01-029E**

Vehicle - Engine Crankcase and Subsystems Flushing Info. INFORMATION

Subject: Unnecessary Flushing Services, Additive Recommendations and Proper Utilization of GM Simplified Maintenance Schedule to Enhance Customer Service Experience

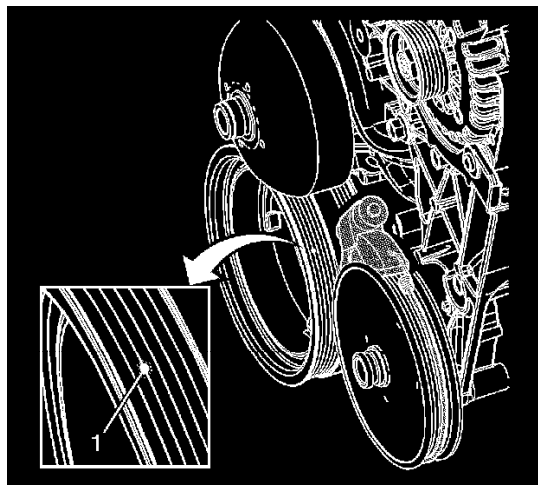
5. Put on the laser safety glasses provided with the tool.
6. Depress the switch on the rear of the tool to activate the light beam.
7. Rotate the power steering pulley as required to project the light beam onto the crankshaft balancer pulley grooves.
8. Inspect for proper power steering pulley alignment.
 - If the laser beam projects onto the second rib or raised area (1), the pulleys are aligned properly.
 - If the laser beam projects more than one-quarter rib 0.9 mm (0.035 in) mis-alignment, adjust the position of the power steering pulley as required.
 - Refer to SI for Power Steering Pulley Removal and Installation procedures.
9. Install the serpentine belt to the accessory drive system in the original orientation.
10. Operate the vehicle and verify that the belt noise concern is no longer present.
